Smoke and Dye-Water Observation Summary

Western Run Pilot Project - Baltimore Maryland

INSPECTION REPORT

REMARK: DYE TEST 70 B 2

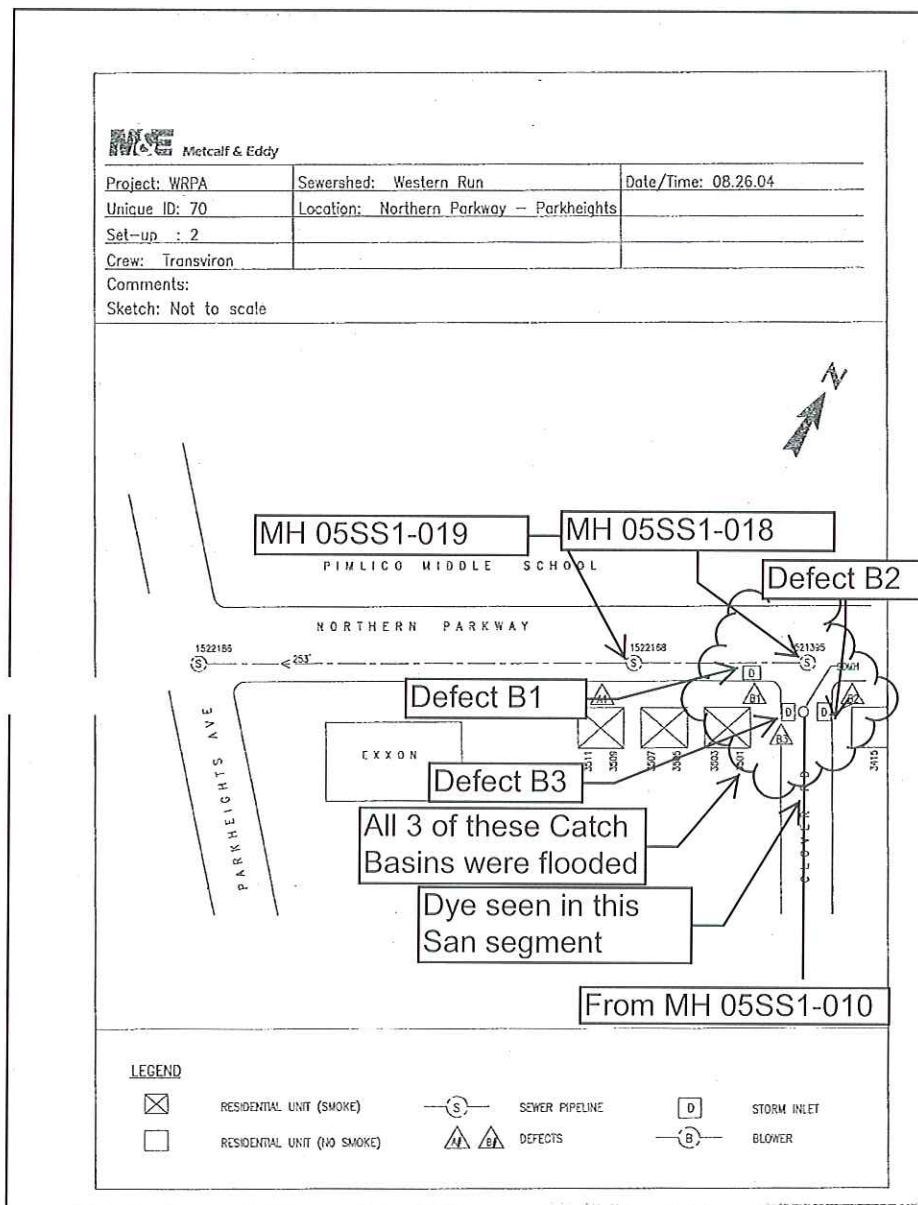
Sketch No: 70

Additional Comments: THE SAME JOINT LEAKED FOR ALL THREE FLOODING, TUED IT TWO TIMES.
40.65' TOTAL TV FT.
